CRYSTAL LAKE DAM

JEFFERSON COUNTY, MISSOURI

MO 30462

# PHASE 1 INSPECTION REPORT NATIONAL DAM SAFETY PROGRAM

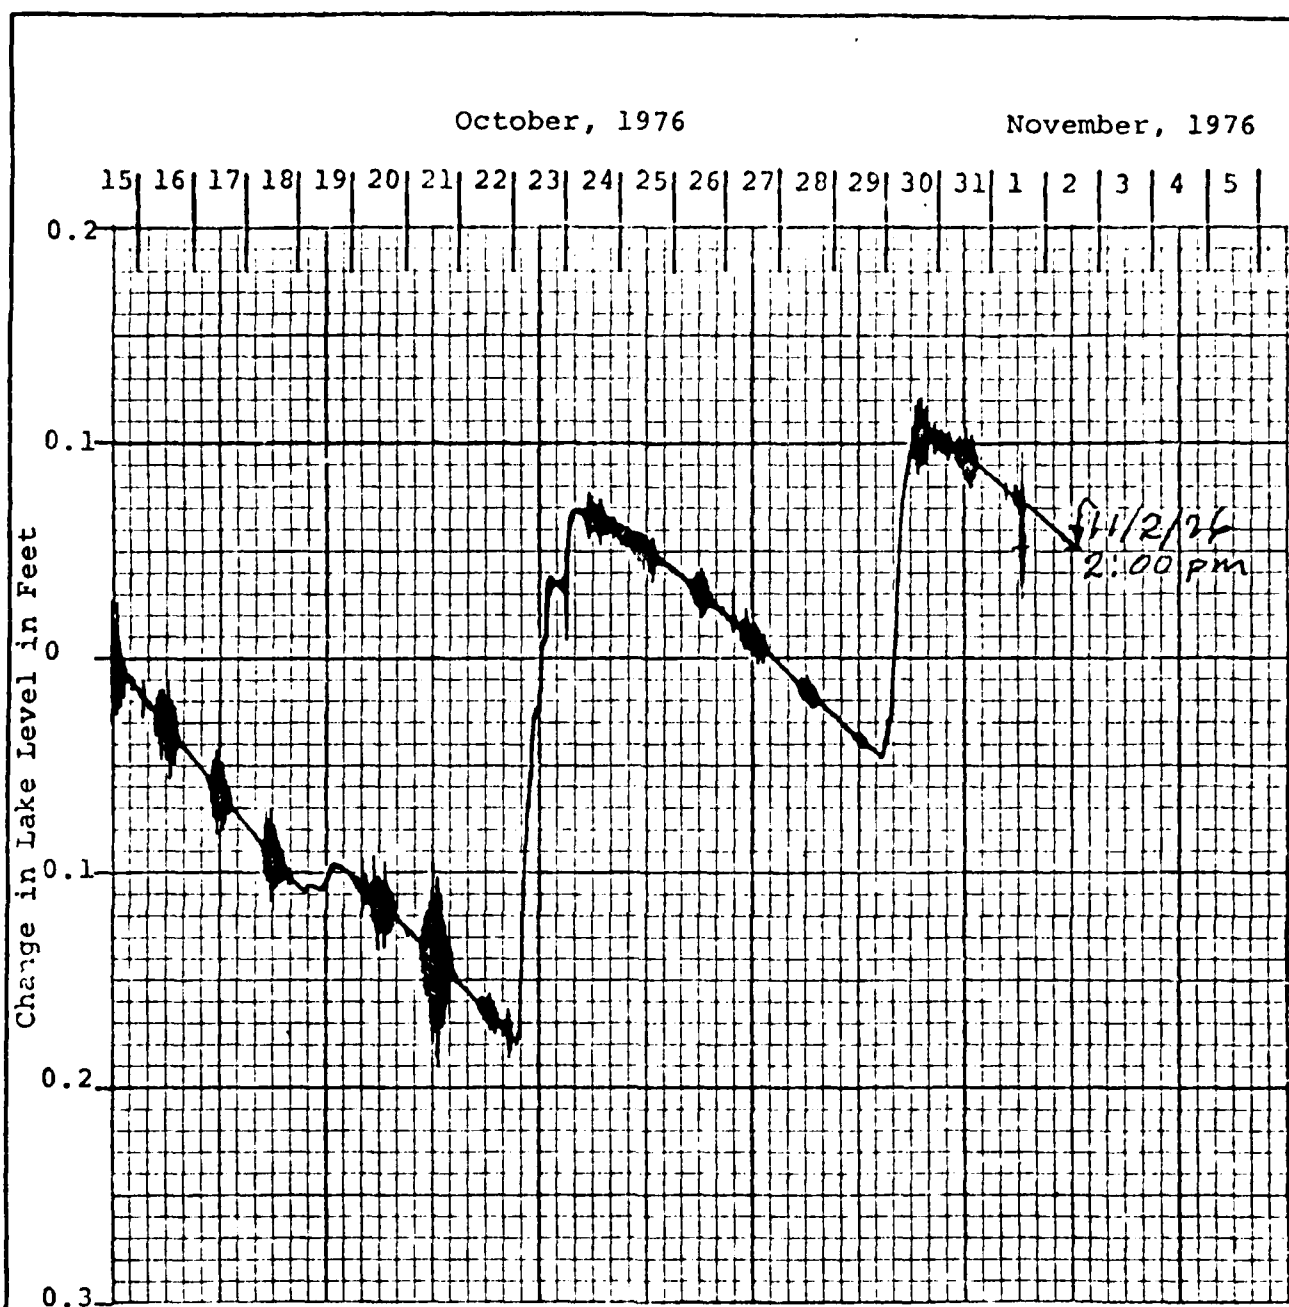
Figure 2

As it was relatively dry prior to the time the recorder was installed, the initial rate of fall in the lake level was probably not affected to a great extent by recharge. As a result, it appears that the rate of leakage from the lake is about 14.5 gpm for the lake level at the time. The rate of leakage would increase some if the lake were full. The amount of increase is not known, but it probably would not be more than about 25 percent. At a leakage rate of 14.5 gpm the total loss would be about 7,500,000 gallons as shown on Figure 3.

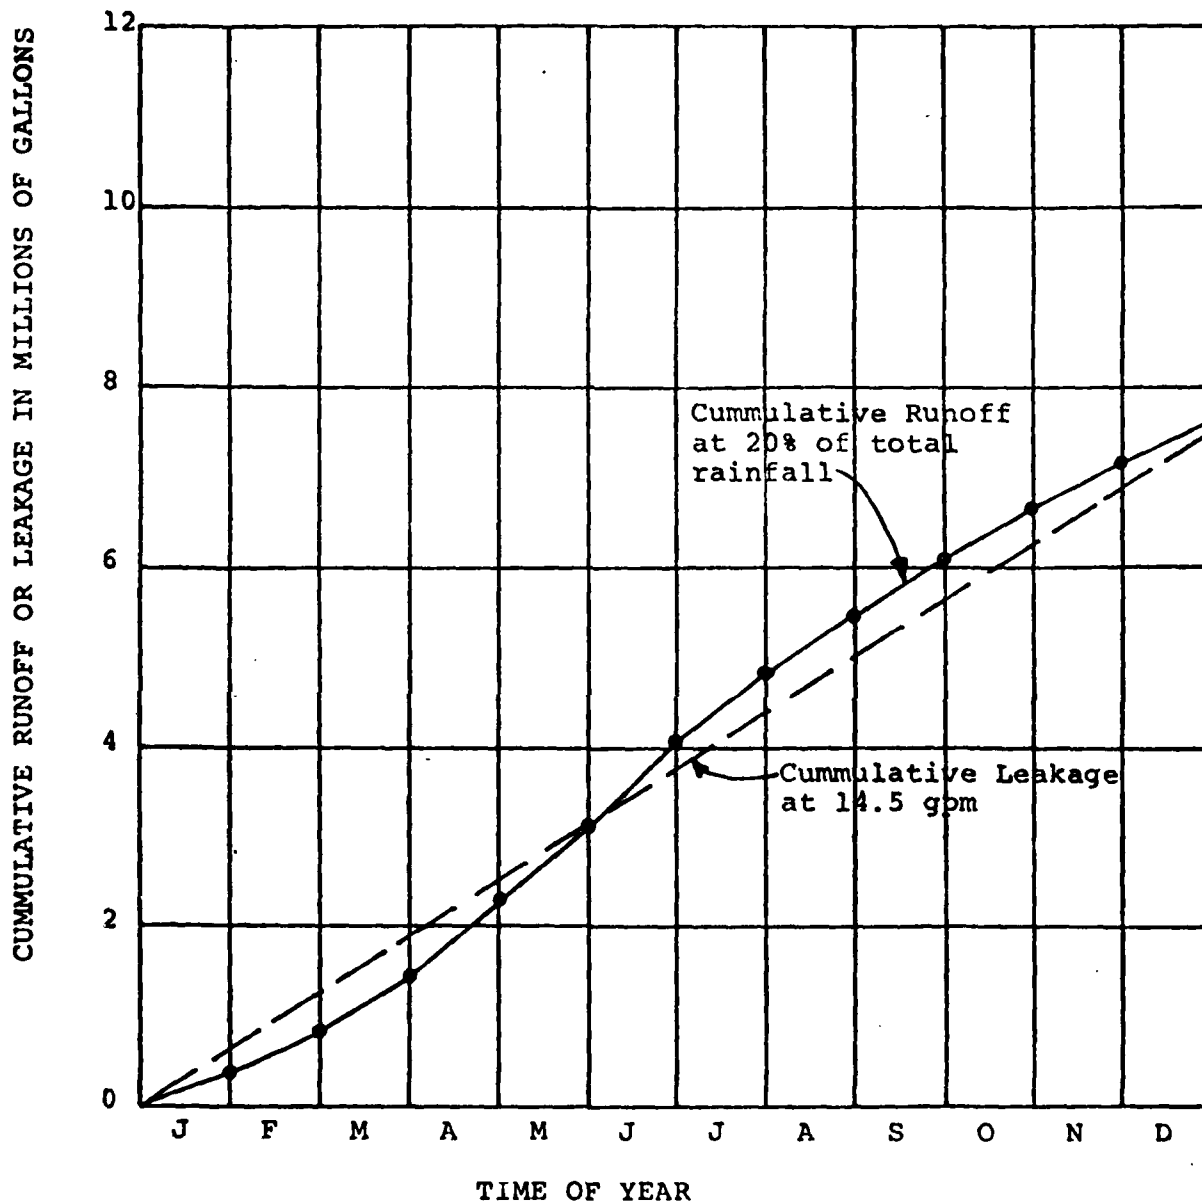
Figure 3

The average runoff for each month is not known but would no doubt be greater than the apparent rates of runoff measured. The average yearly runoff to make up the 14.5 gpm leakage would be about 20 percent. A plot showing 20 percent runoff for each month is shown on Figure 3.
